**Maine Department of Transportation  
Research Highlights  
May 2001**

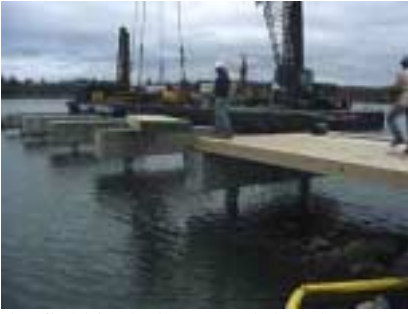
**FRP - Reinforced Wood Structures.** The UMaine Advanced Engineering Wood Composites Center has been researching and perfecting the use of fiber reinforced polymer (FRP) - reinforced wood structures. FRP reinforced wood allows the use of Maine timber species in the transportation infrastructure because of the added strength. Shown here is the Town of Milbridge Municipal Pier which was constructed with a FRP - reinforced glulam wood structural slab. The project goals were to save construction time, reduce maintenance costs and protect and strengthen the wood. The reinforced slabs weigh only 1/3 as much as prestressed concrete yet have the same strength and stiffness. This project was partially funded through FHWA's Innovative Bridge Research & Construction Program and will be monitored over time for performance and durability. Other applications being demonstrated in

the field include FRP-glulam beams with glulam bridge deck, FRP-glulam beams with integral concrete bridge deck, FRP splices for repair of timber pile bents, and FRP reinforced Oriented Strand Board panels for temporary bridge decks.

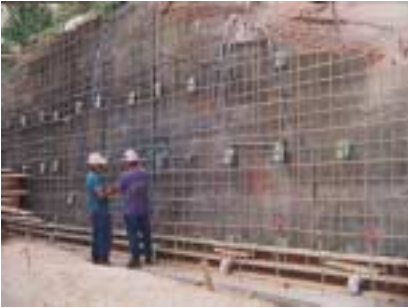
**Soil Nail Walls in Maine.** Two soil nail walls have been constructed and instrumented on Maine DOT projects. Conventional retaining walls in areas subject to heavy freezing are normally designed with a zone of non-frost susceptible backfill that exceeds anticipated frost penetration depth. Because backfill is not used in soil nailing, designers have little control over soil properties of the retained earth. A soil nail wall along Rt. 201 in Moscow, Maine retains frost susceptible glacial till, and was designed with 10cm of facial polystyrene insulation in hopes of limiting frost penetration and ensuing heave. UMaine instrumented four areas of the Moscow wall and monitored for nail stresses, wall stresses, wall rotations, retained earth movements, the presence of water, and ground temperatures. Data analysis shows that insulation plays a large role in minimizing frost loads on nail and wall

components. It was felt the insulation limited frost penetration to the upper levels of wall. Maximum nail head tension occurs as a result of frost action. In fact, a portion (5% to 74%) of the maximum frost induced nail stress is permanent and cumulative. Further analysis determined that the Moscow wall could have been more economically insulated by using 5cm (half the thickness used) of insulation placed at the face and at the wall top. A report on the first and second winter performance has been completed. Another report will be prepared that includes the third winter.

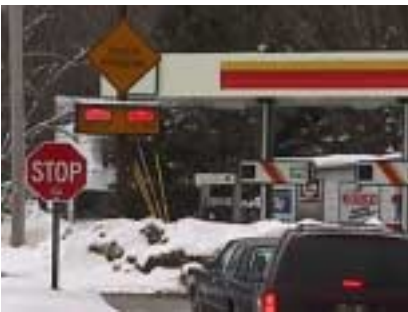
**Evaluation of Vehicle Actuated Warning Signs.** Collisions at intersections are one of the most common types of vehicle crashes in Maine. Many of these locations are blind intersections. Installation of full signalization to address this problem cannot always be justified due to cost, maintenance concerns and traffic delays on the major through highway. The objective of this project is to test and evaluate vehicle-actuated warning signs to reduce the incidence of collisions at selected intersections having severely limited sight distances. A vehicle actuated system was installed at a rural intersection along Rt. 201A in Norridgewock, Maine. The goal is to warn approaching traffic when a vehicle is about to enter the highway and also to warn an entering vehicle when an unseen vehicle is approaching from the blind approach. Before and after evaluations using Traffic Conflict Techniques are being

performed. Preliminary results show that drivers are more cautious entering the highway. However congestion along the minor legs has increased.

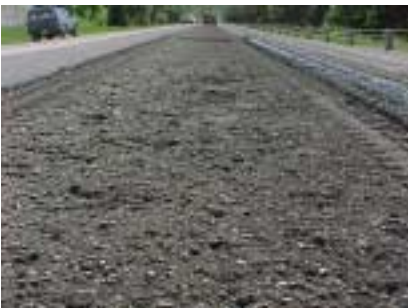
**Rational Mix Design Procedure for Full Depth Reclamation.** Full depth reclamation is a recycling technique that shows great potential in saving material and costs, restoring proper roadway cross slope and grade and providing a crack resistant base course. However, the selection of stabilizing additive type and amount is based on experience and outdated practices. This study being conducted by Worcester Polytechnic Institute and Maine DOT will develop a rational mix design procedure and evaluate the performance of different additives. Preliminary results show the Superpave gyratory compactor can be used successfully in the mix design process. It is recommended that for selecting optimum additive contents to use total fluid content criteria versus density and resilient modulus. Also, addition of emulsion, lime or cement improves the durability of samples, compared to mixes with water only. Test

sections along Rt. 201 in Caratunk, Maine are being monitored for performance. Material samples from other states will be tested to verify the proposed mix design procedure. An AASHTO Guide will be proposed.
